Magpie 2006 ILI Inspection: Executive Summary Report. (11+cover sheet).

Executive Summary

Dixie Pipeline Company

Hattiesburg Station to Demopolis Station
12 in Propane

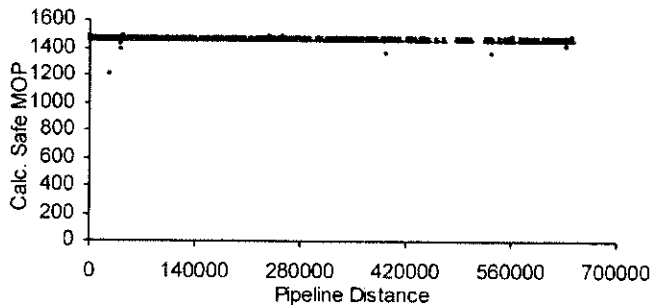
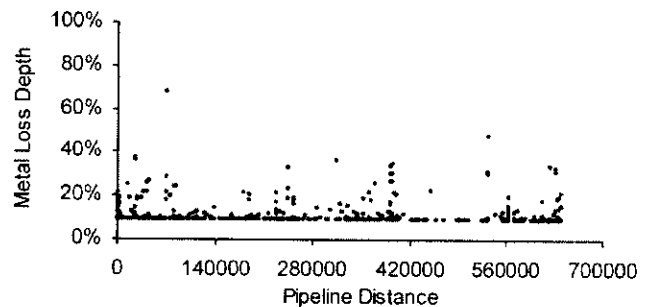
* The number of anomalies where P' (calculated safe max. pressure for an anomaly) is less than P (current established maximum pressure of pipeline) - see ASME B31G

A total of 758 metal loss groups (155 Internal / 603 External) were detected on the inspection survey, of which the deepest is reported at 68%. Using an established maximum operating pressure of 1,454 psi, 6 of the metal loss features appear to be pressure reducing.

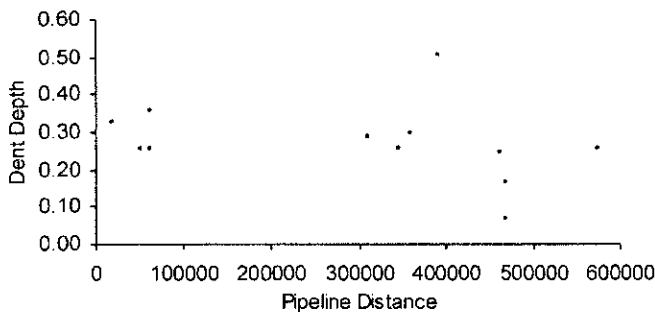
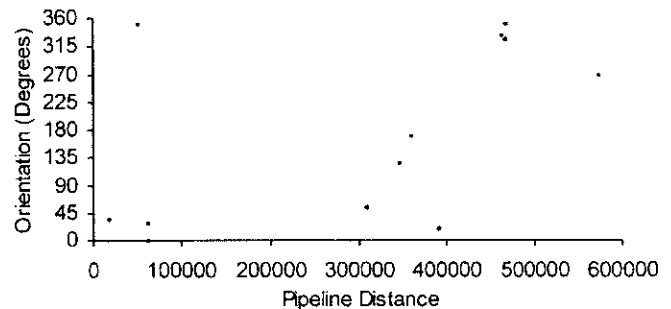
A total of 12 deformations (12 dents) were detected on the inspection survey, of which the deepest is reported at 0.51 in.
